## 17/ TOWN HALL

Location: Verdon St

Date: 1883

## INGLEWOOD TOWN HALL - 1883

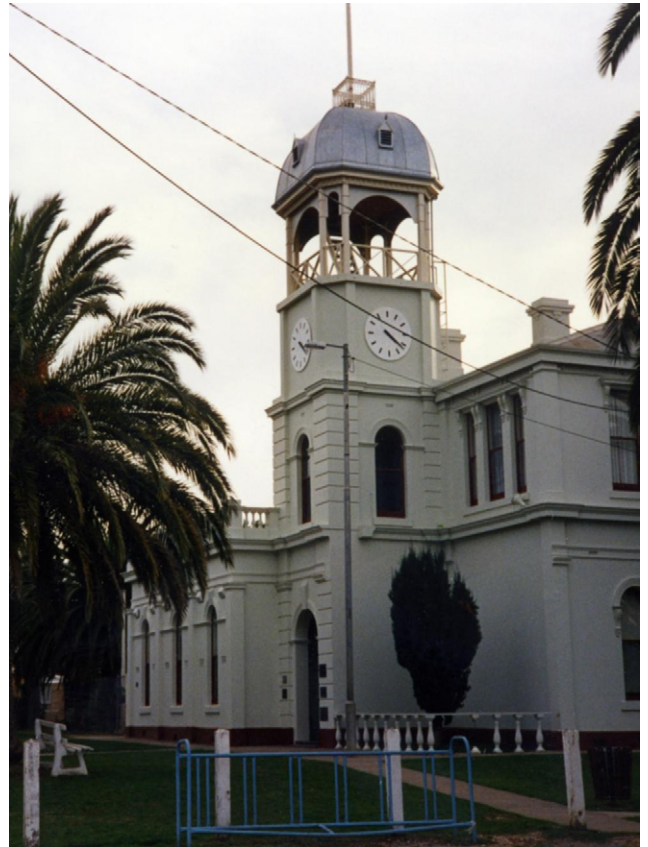
A double storeyed, towered and stuccoed building. Arched windows and doors are outlined with classical architraves and the parapet is balustraded. The main entrance porch is bordered with Jacobean strap work which extends upward to the clock tower. Umber posts support an aluminium cupola replicating the original wooden cupola which was removed in 1970. Several mature palm trees stand to the front of the hall. The Hall is built of local bricks from Phillips' brick kilns.
